# **SURFERS' POINT MONITORING SPRING 2024**

## **Monitoring Report Update and Synthesis 2011-2024**

**Prepared for  
BEACON**

**December 2024**

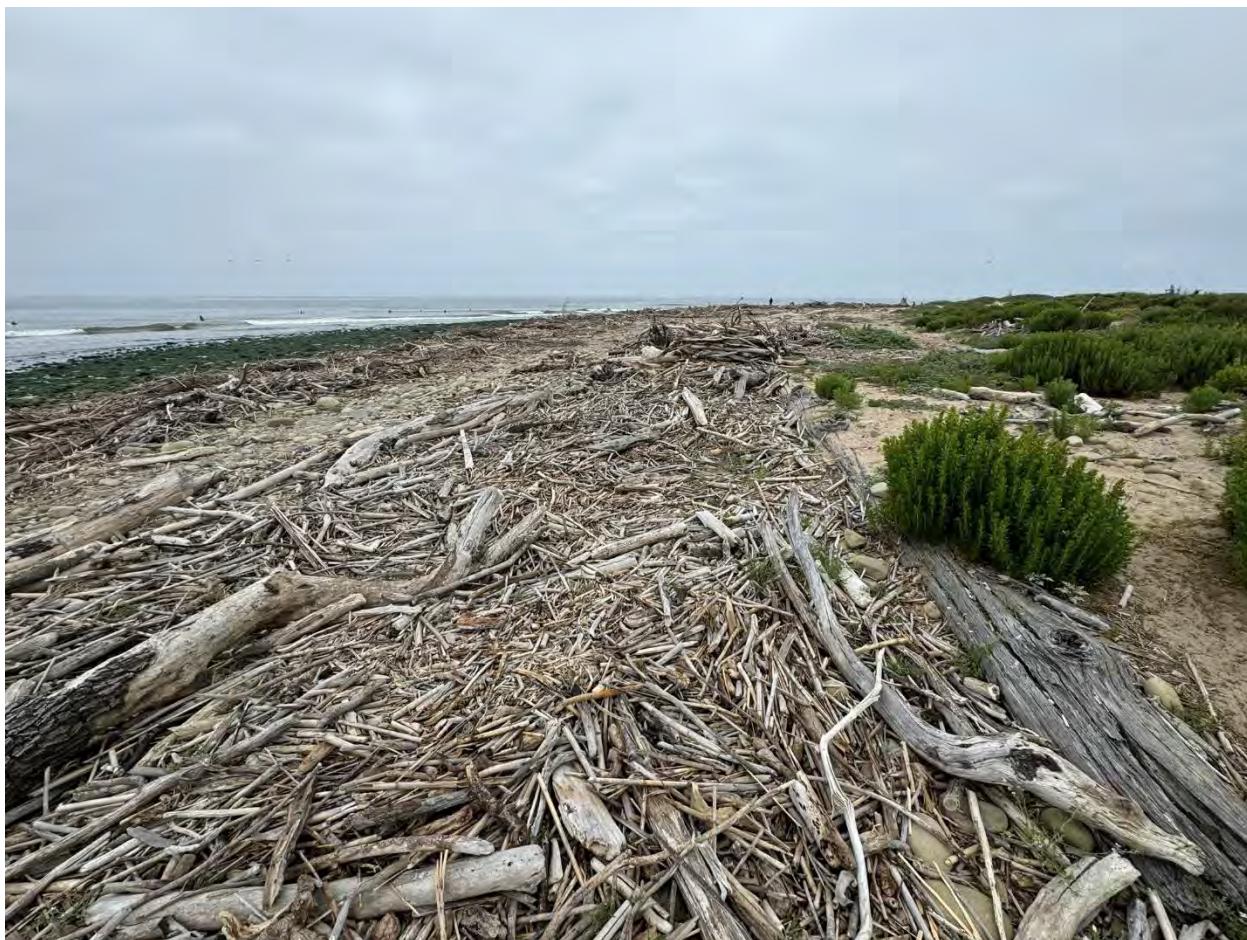
**Figure 15.**

Typical beach changes are visible in the Phase 1 profiles for the 2023-2024 monitoring period. The beach shows an elevated profile during the spring and summer months, and the fall and winter months show a lower profile. Looking at the Emma Wood Reference Site, a raised profile at approximately Station 1+60 is visible for both the December 2023 profile and the May 2024 profile, which onsite appears to be a large and wrack bar created from the January 2023 coastal and fluvial storm events (Figure 15). From the same events, a similar cobble and wrack bar is visible on Profiles A, B, and C around Station 2+20, and Profile D around Station 2+40. This bar is further discussed in Section 3.3.

Cobble and Wrack Bar Around Profiles A, B, and C (May 29, 2024)

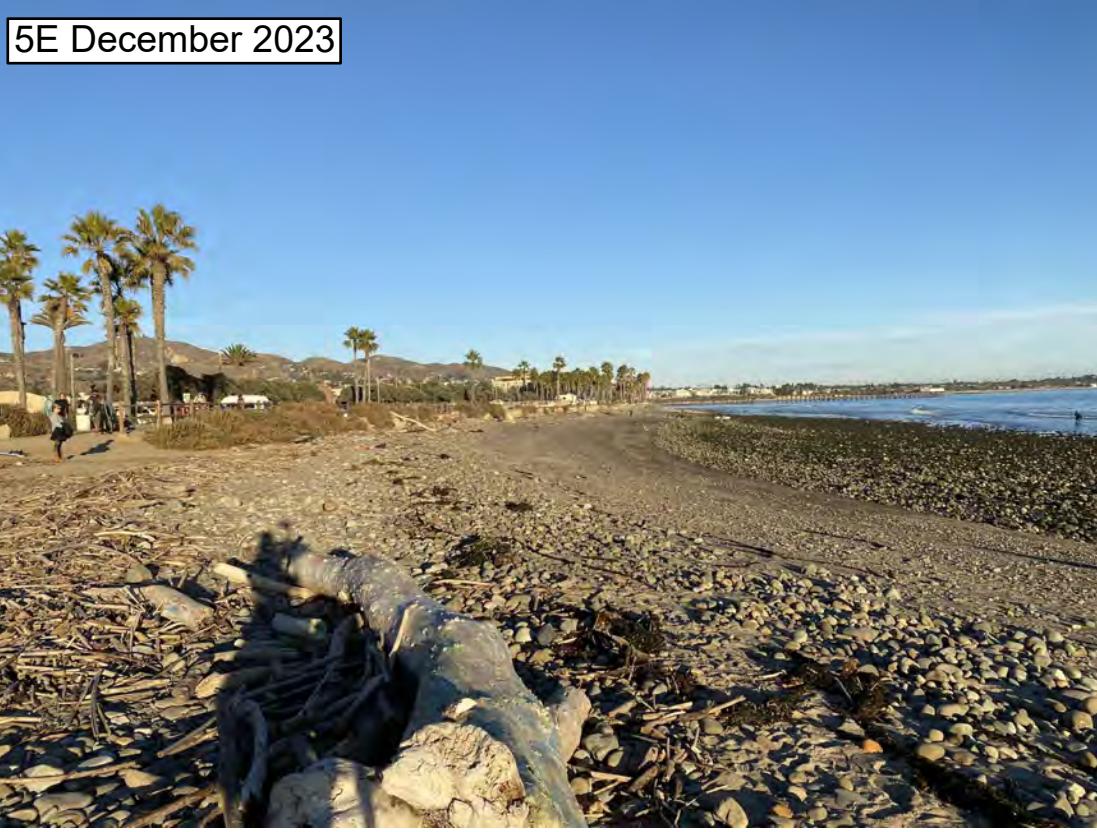
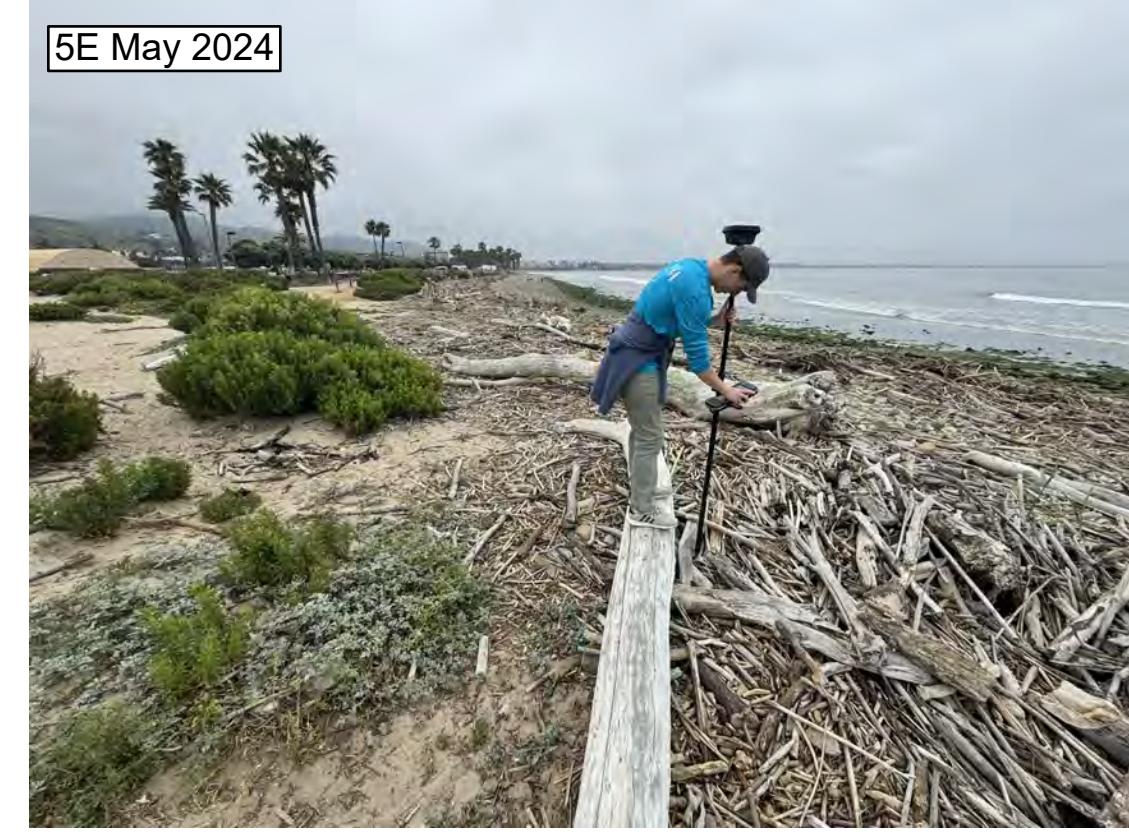
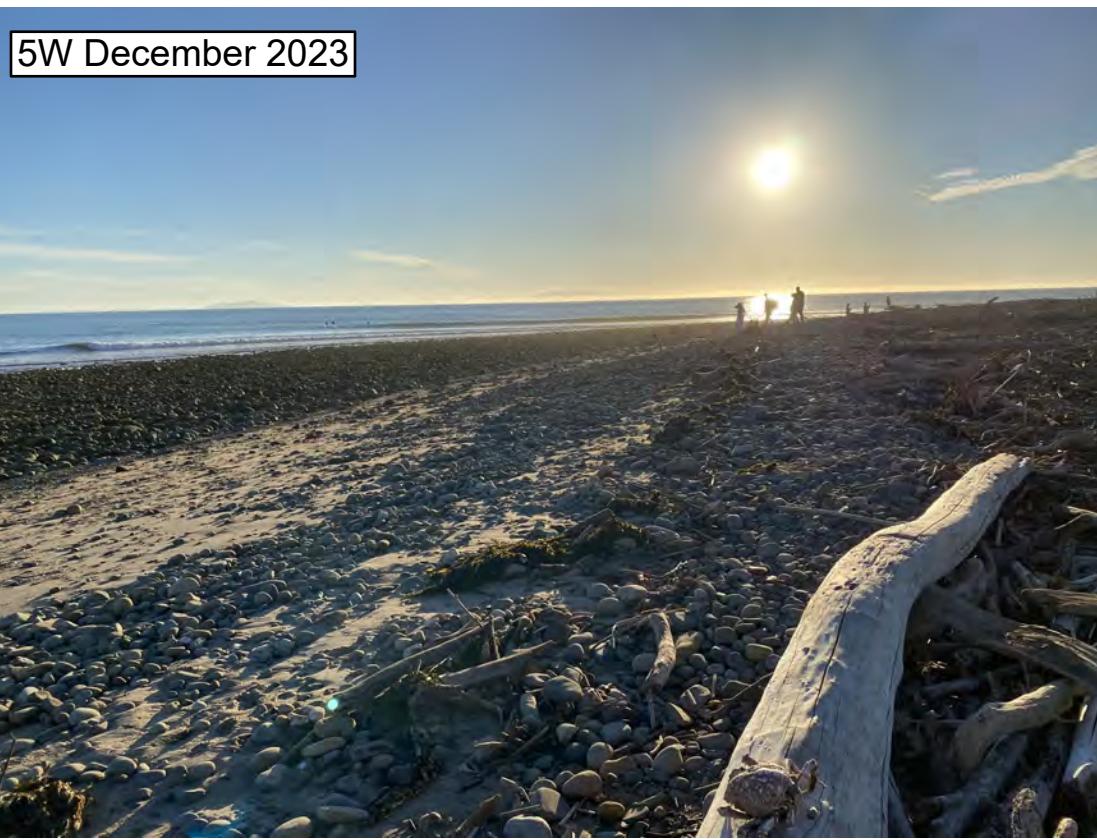
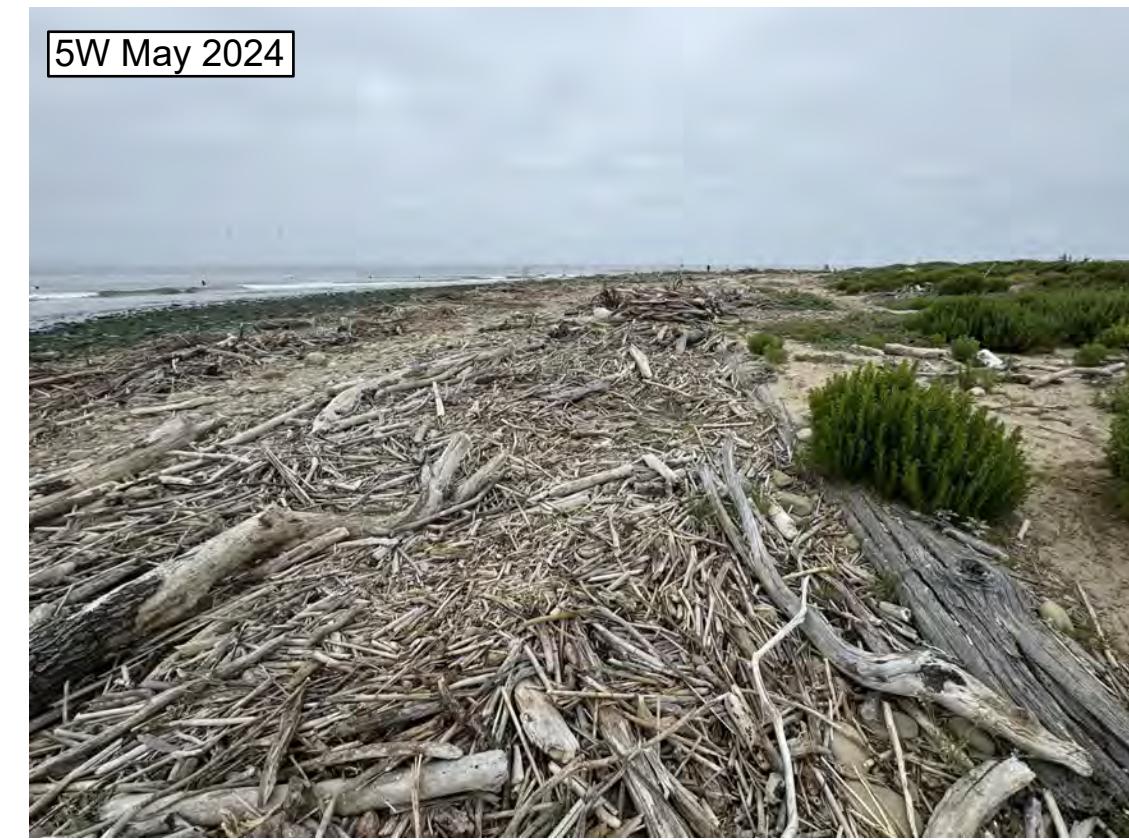
5E December 2023

5E May 2024

5W December 2023

5W May 2024

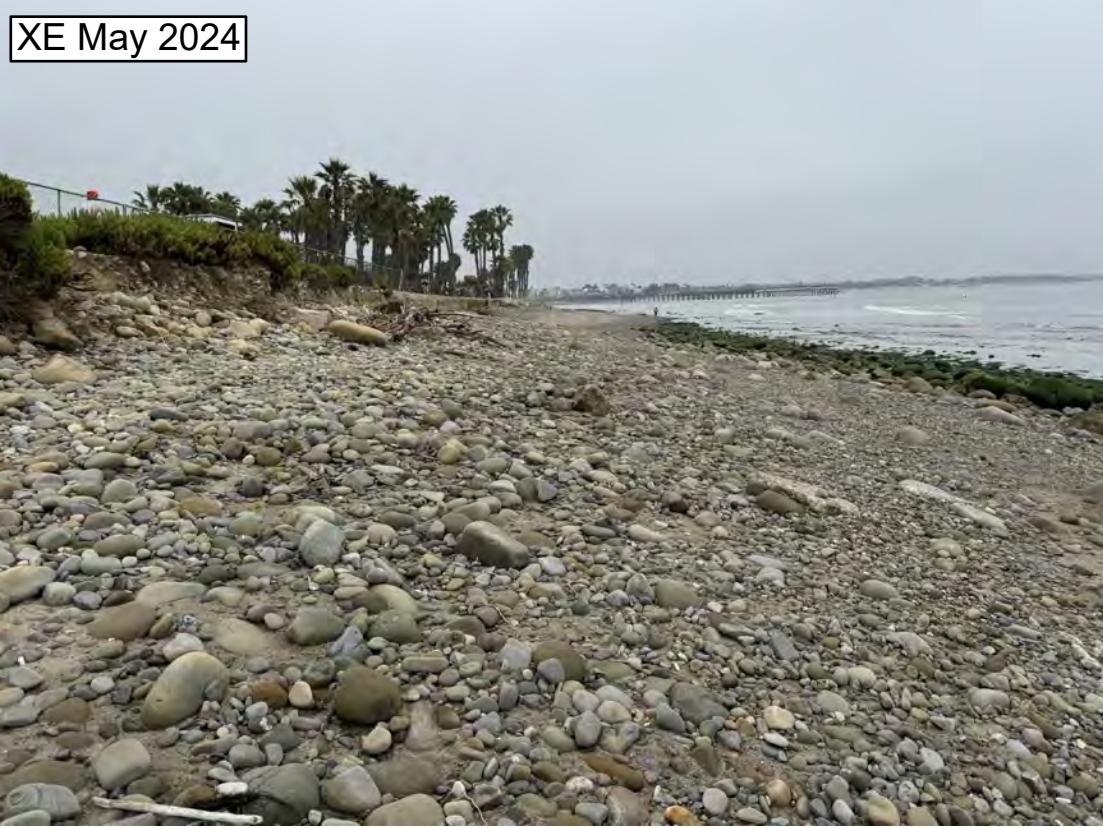
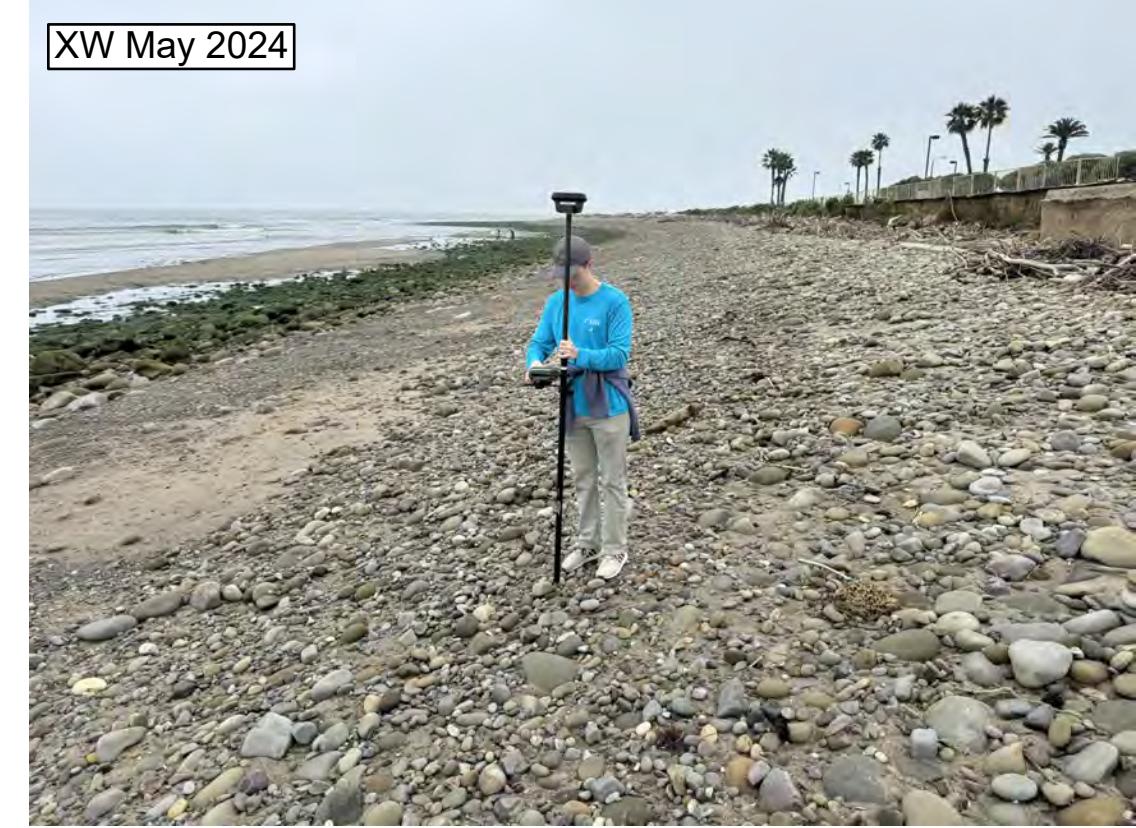
In May 2024 at locations XE and XW (between photo locations 5 and 6), post winter beach conditions in the Phase II monitoring area are showing eroded pavement and sea wall from winter storm events. Large amounts of cobble are dispersed on the beach. These same sea wall and pavement locations are intact in November 2023 prior to the winter storm events.

XE May 2024

XW May 2024

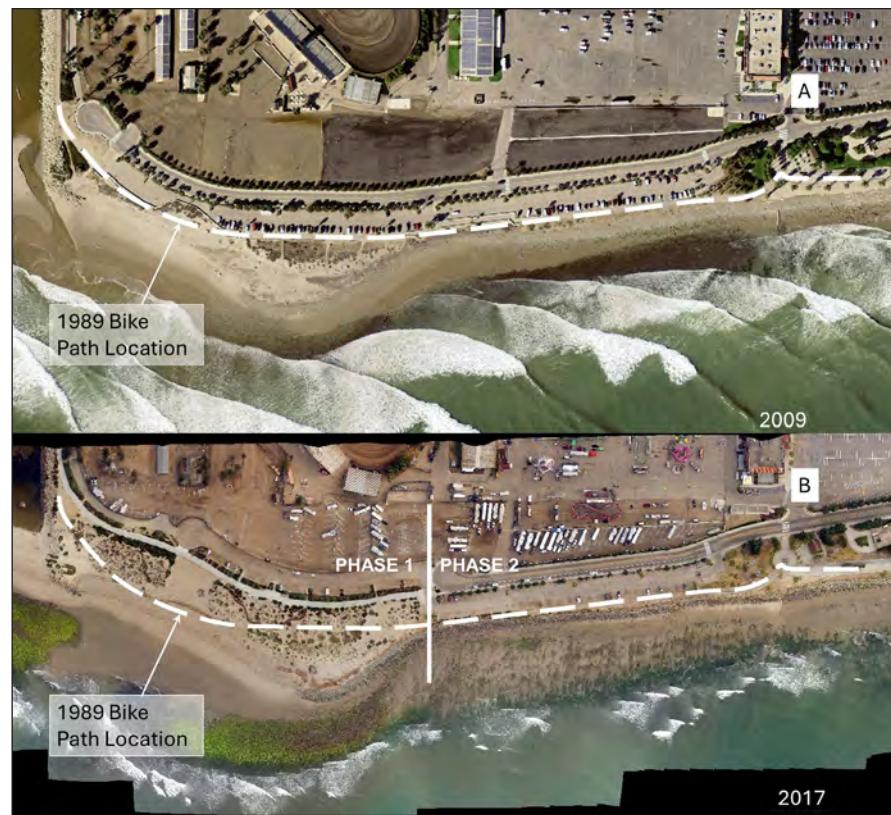
**Figure 5. Aerial photographs Surfers Point Phase 1 (A) before (2009) and (B) after (2017) construction. The solid line indicates the seaward edge of development before construction. Source: 2009 imagery collected by USACE; 2017 imagery collected by Sierra Overhead Analytics.**

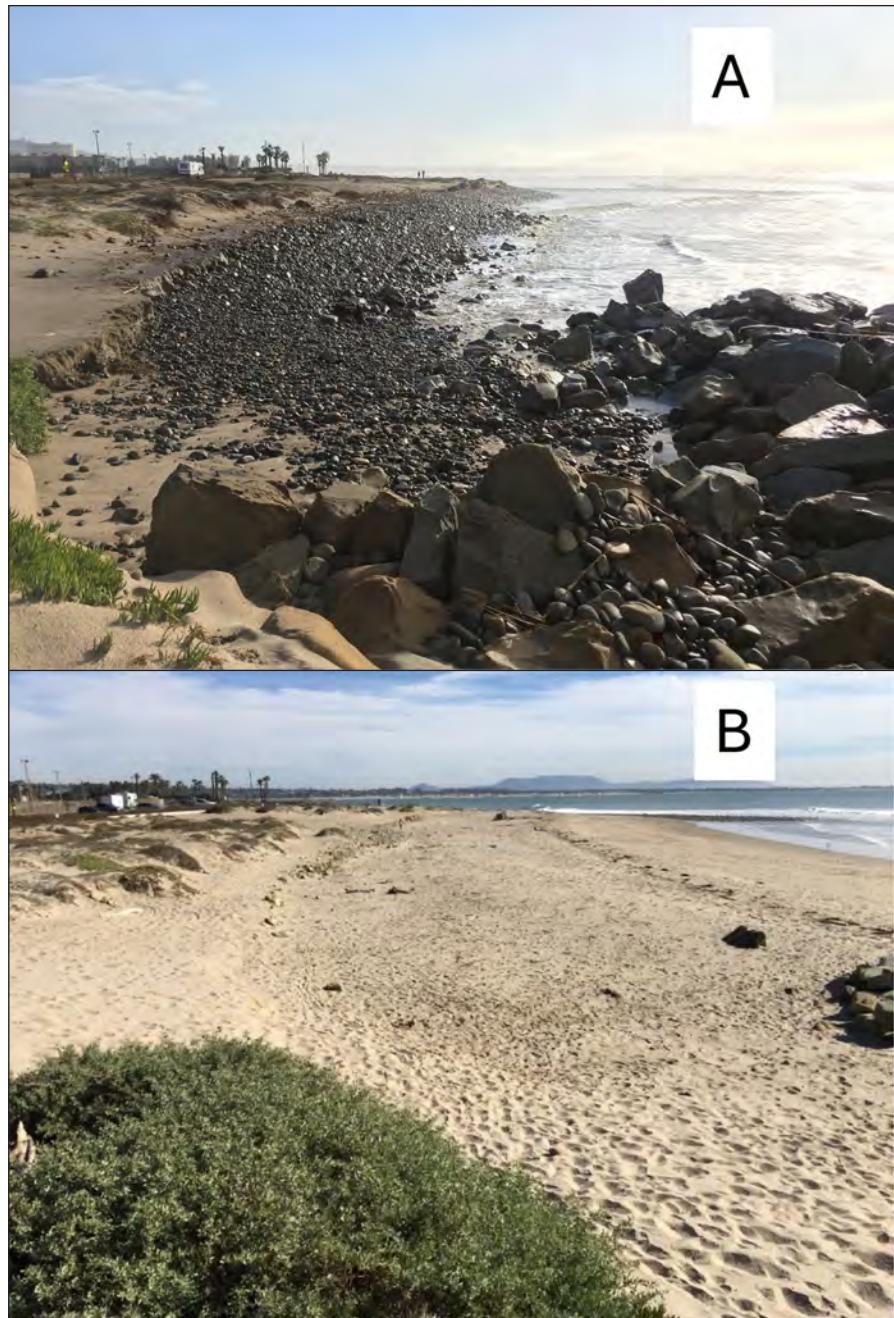
**Figure 9. Photographs of erosion by large-wave event on 11 December 2015 and subsequent recovery.**

**(A) March 2016 eroded shore with exposed cobble. Source: Paul Jenkin/Surfrider Foundation.**

**(B) November 2017 recovered shore with sand covering cobble. Source: ESA et al. 2018.**

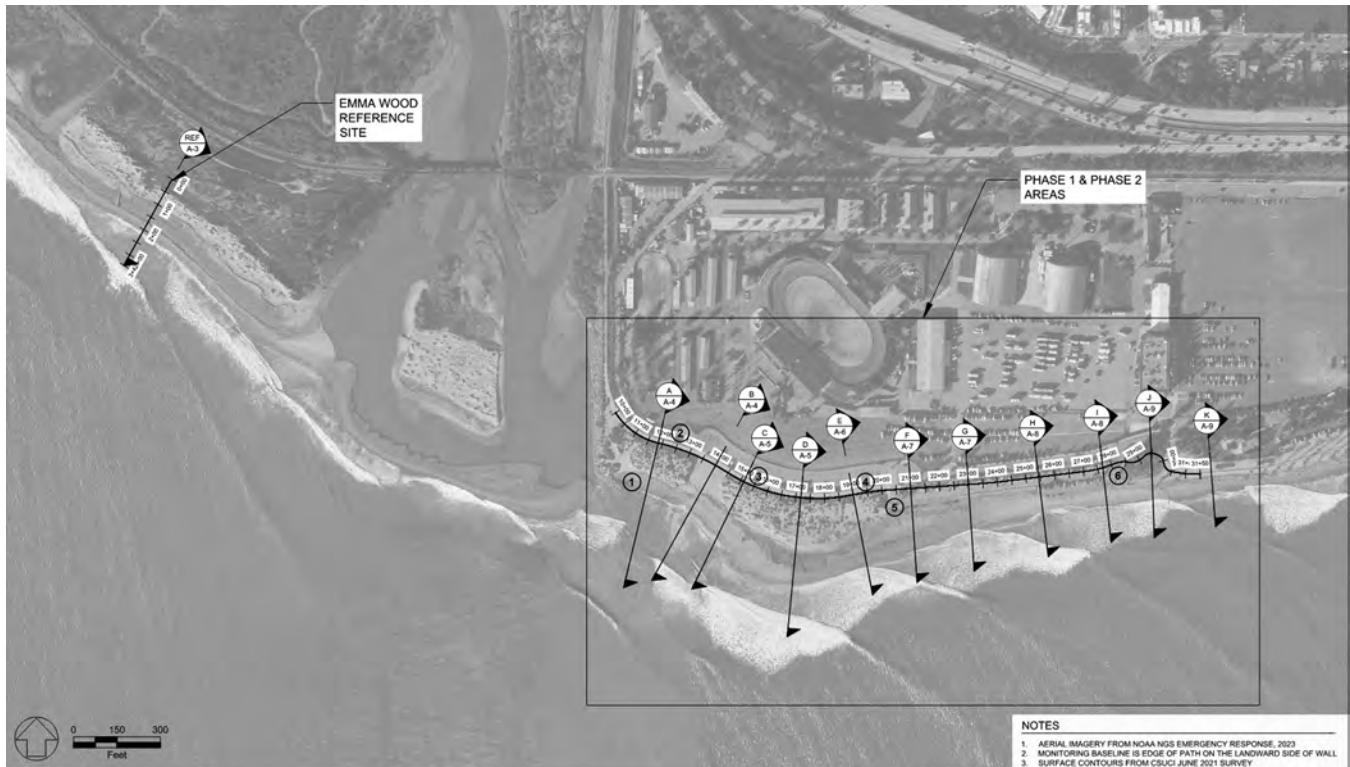
**Figure 10. Elevation survey transects (Profiles A-J and REF) at Surfers Point Phase 1 (A-E), Phase 2 (F-J) and the Emma Wood reference Site (REF). The shore-parallel line is a station line along the new pedestrian path. Source: ESA et al. 2024.**
